# Refurbished OEC 9800 C-arm

## **EDI OEC 9800 C-arm Refurbishing Process**

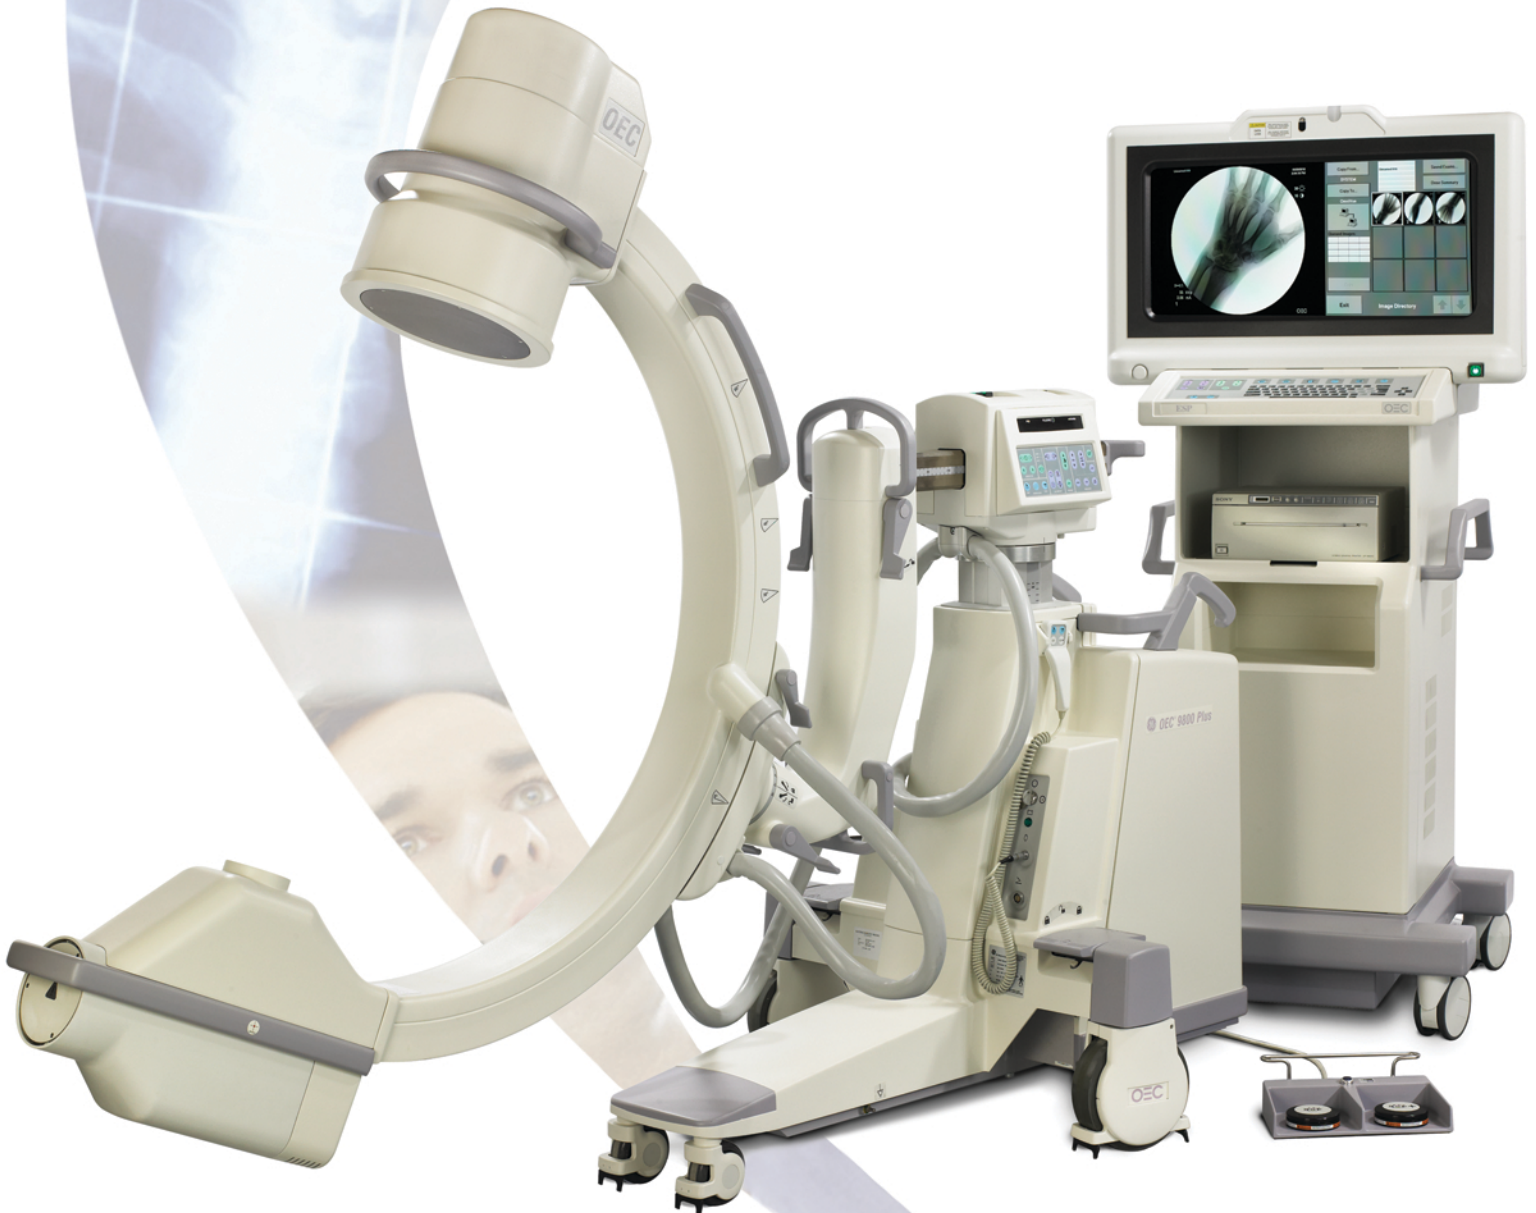
All OEC 9800 systems go through a multistep refurbishing process. EDI takes great pride in the fact that each unit is restored to a like-new status. Pain Management, Orthopedic and Rehabilitation Services are just a few of the applications utilizing the EDI refurbished OEC 9800 C-arm. The rotating anode allows for greater penetration and resolution

for the lumbar area, when performing localizations or other work involving the thicker anatomical areas. The 1K X 1K CCD technology used in the OEC 9800 image system allows for crisp, clear imaging. For whatever the purpose, an EDI refurbished OEC 9800 will deliver the results you can depend on.
